Manhole Inspection Summary

Manhole # S49EE_004MH

Insp Date: **7/15/08 10:23 AM**

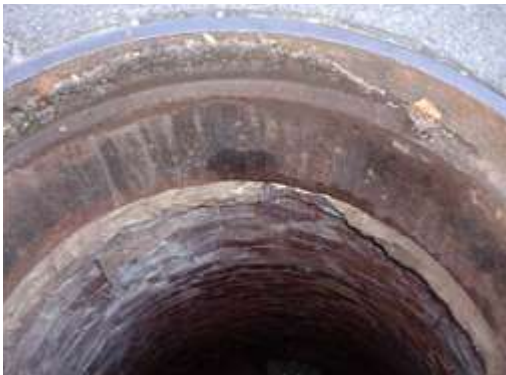
Defect 2

frame leaks

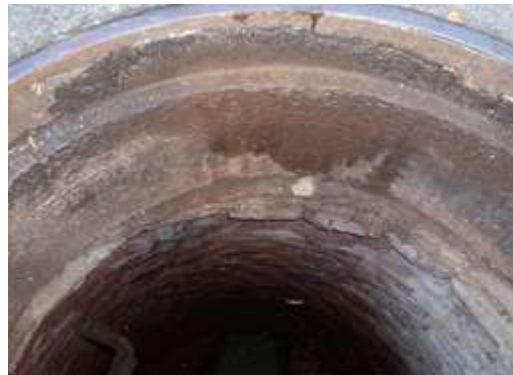
Defect 1

Infiltration: ☐ None ☒ **Joint** ☐ Cracks ☐ Mortar ☐ Roots ☐ Wall

Infiltration: ☐ None ☐ Joint ☐ Cracks ☐ Mortar ☐ Roots ☒ **Wall**

infiltration

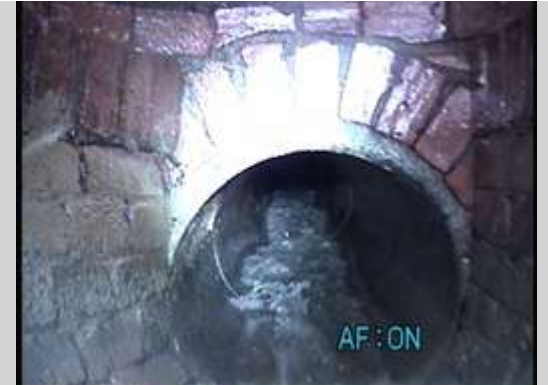
12 O'Clock Outflow

Pipe Height: **15.6** (in.) Rod and Bar (Angled)
Pipe Material: **Clay** ☐ Pipe Lined
Invert Depth: **10.70** (ft.) Flow Characteristics: **Turbulent**
Deposits: ☒ None ☐ Mud ☐ Sludge ☐ Debris ☐ Grease
Silt Depth: (in.) Deposits Extent:
Infiltration: **None** Pipe Seal Cond: **Sound**

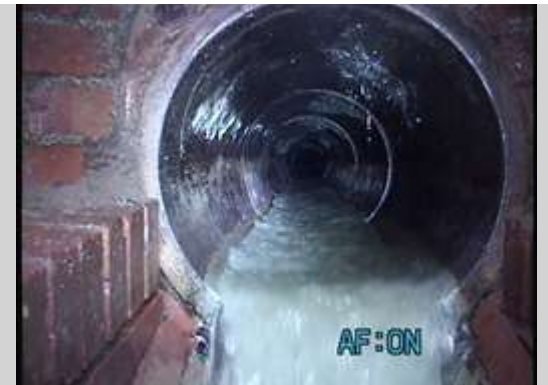
6 O'Clock Inflow

Pipe Height: **15.6** (in.) Rod and Bar (Angled)
Pipe Material: **Clay** ☐ Pipe Lined
Invert Depth: **9.30** (ft.) Flow Characteristics: **Turbulent**
Deposits: ☒ None ☐ Mud ☐ Sludge ☐ Debris ☐ Grease
Silt Depth: (in.) Deposits Extent:
Infiltration: **None** Pipe Seal Cond: **Sound**

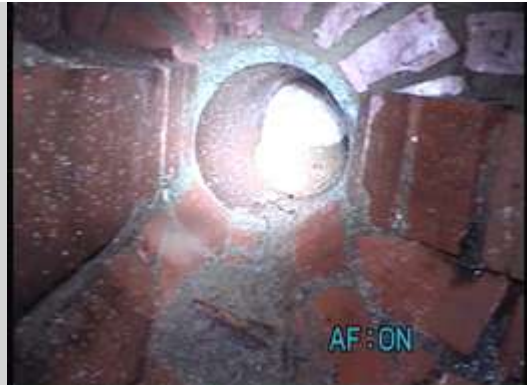
9 O'Clock Inflow

Pipe Height: **8.4** (in.) Rod and Bar (Angled)

Invert Depth: **9.25** (ft.) Flow Characteristics: **None**

Infiltration: **None**

Pipe Seal Cond: **Sound**
